REPORT

December 2013

OPG NIAGARA PLANT GROUP

Glen Access Road/North SAB1 Tailrace Road - Investigation and Recommendations for Road Upgrade

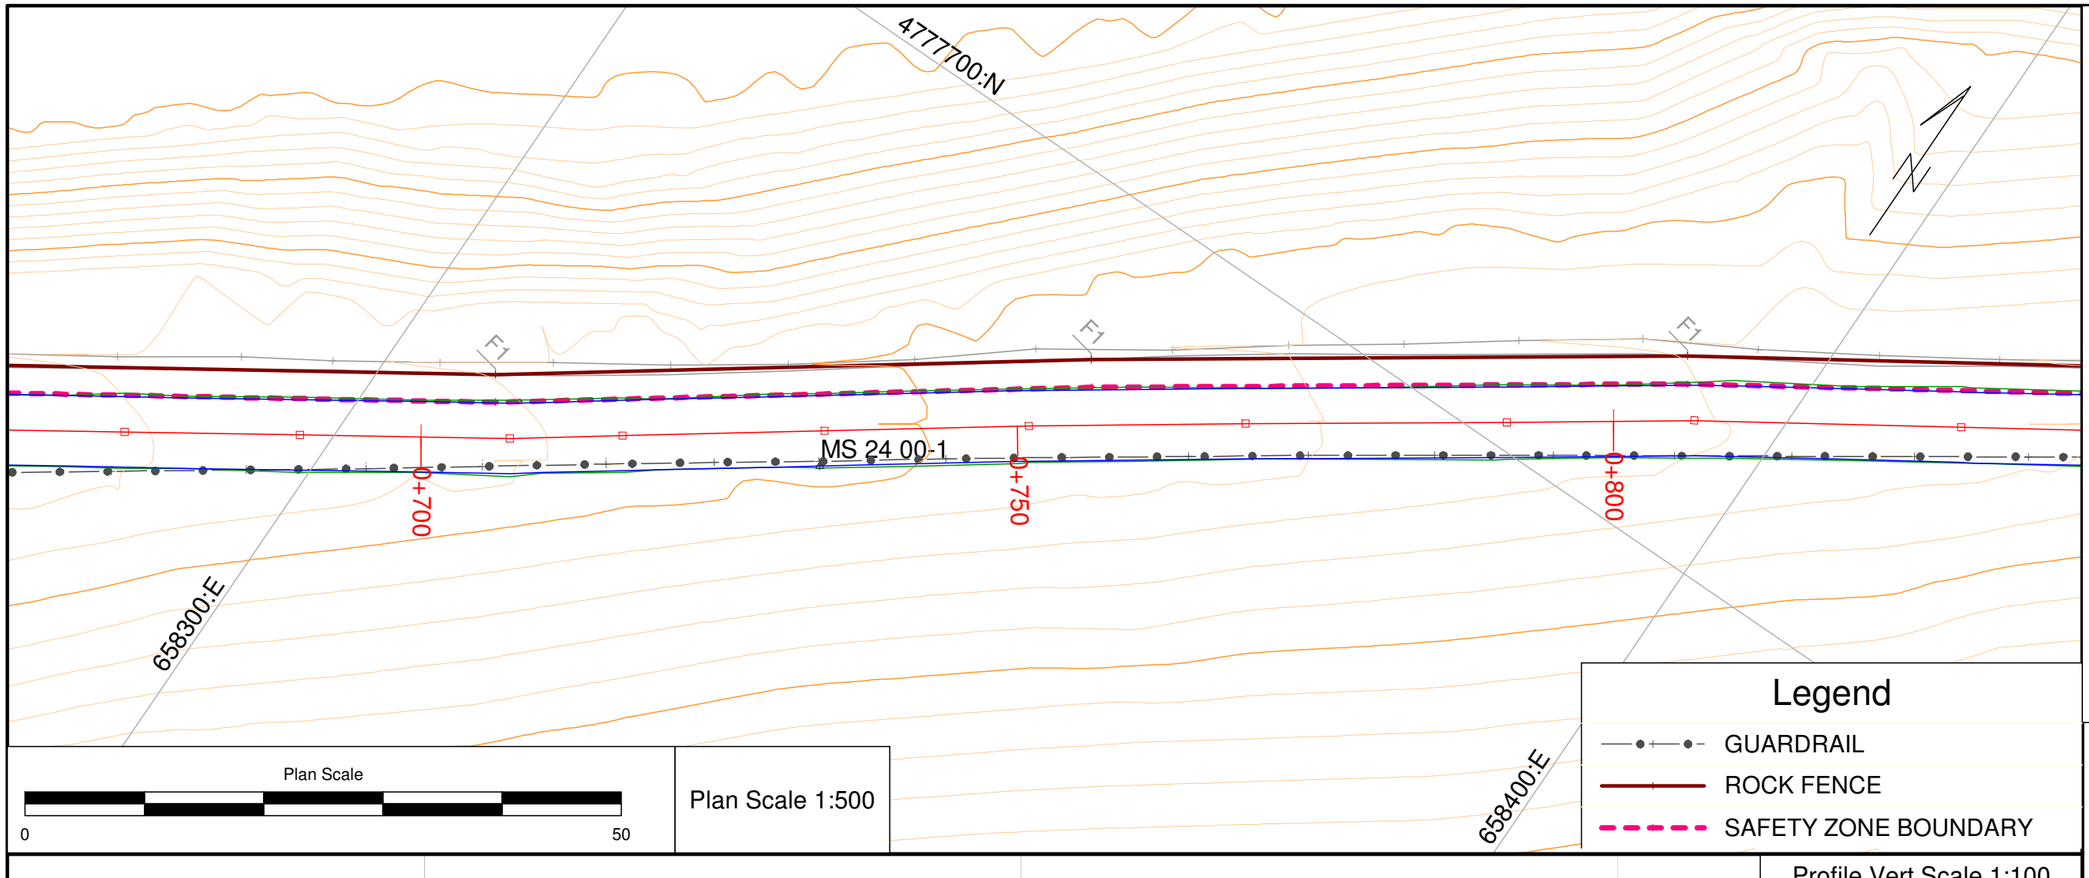
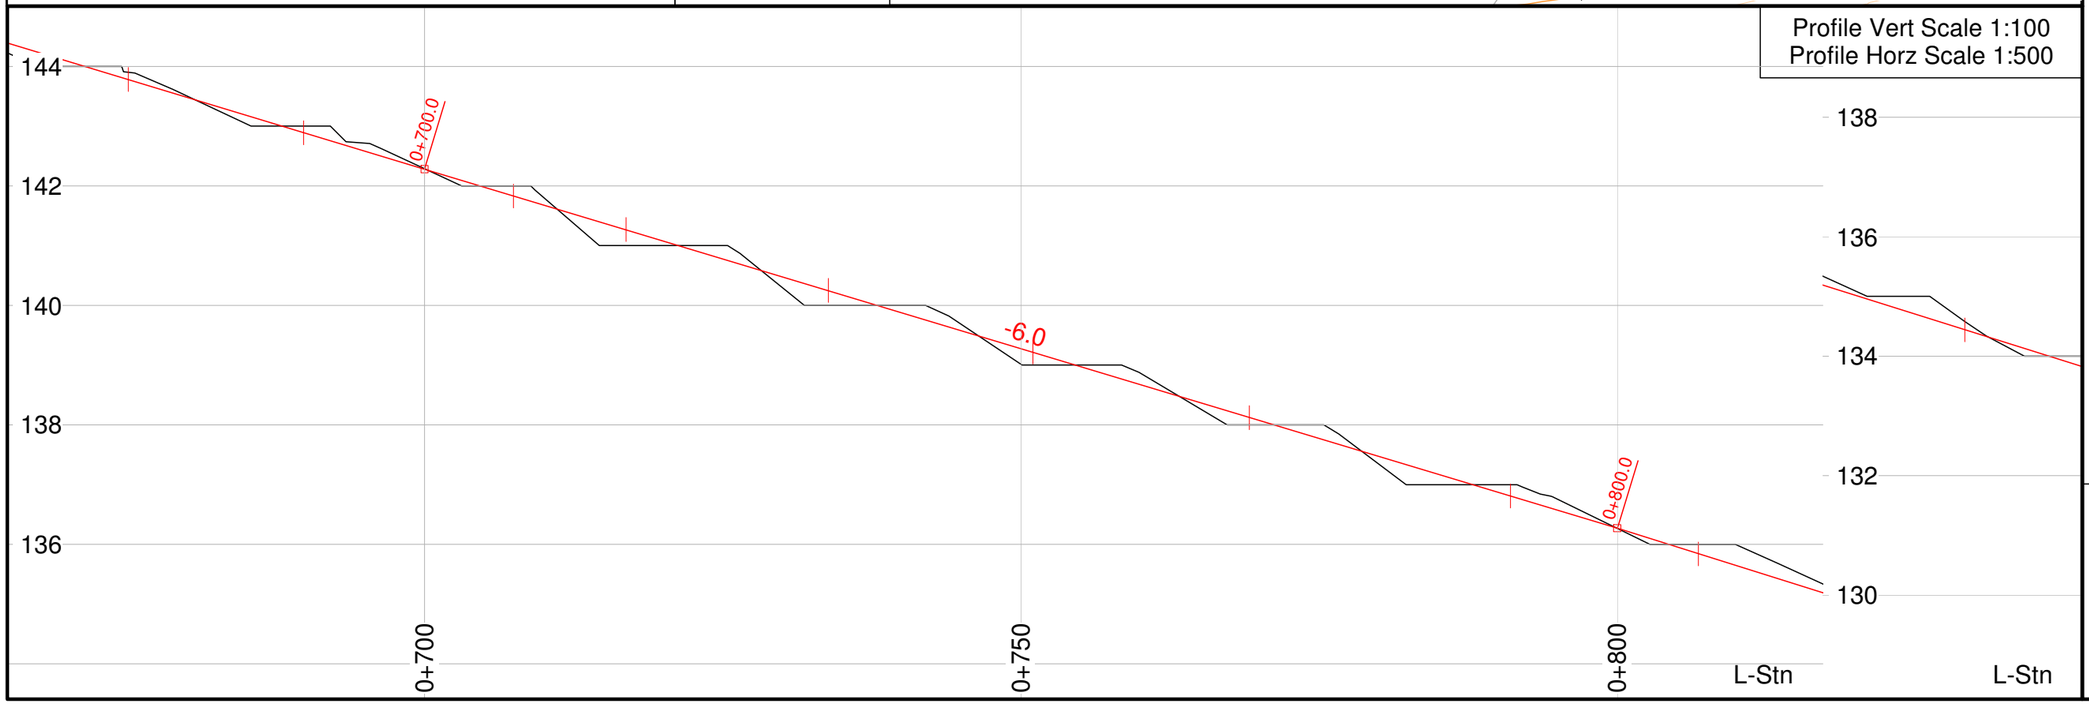
FIGURE 2a

A second approach to determine the length of road with insufficient space was to inspect the plan view of the road produced by RoadEng, Figures 2 (a) to (i). The figures were inspected for the length of road where the right edge of pavement ran outside the guide rail. Table 3 shows the results.

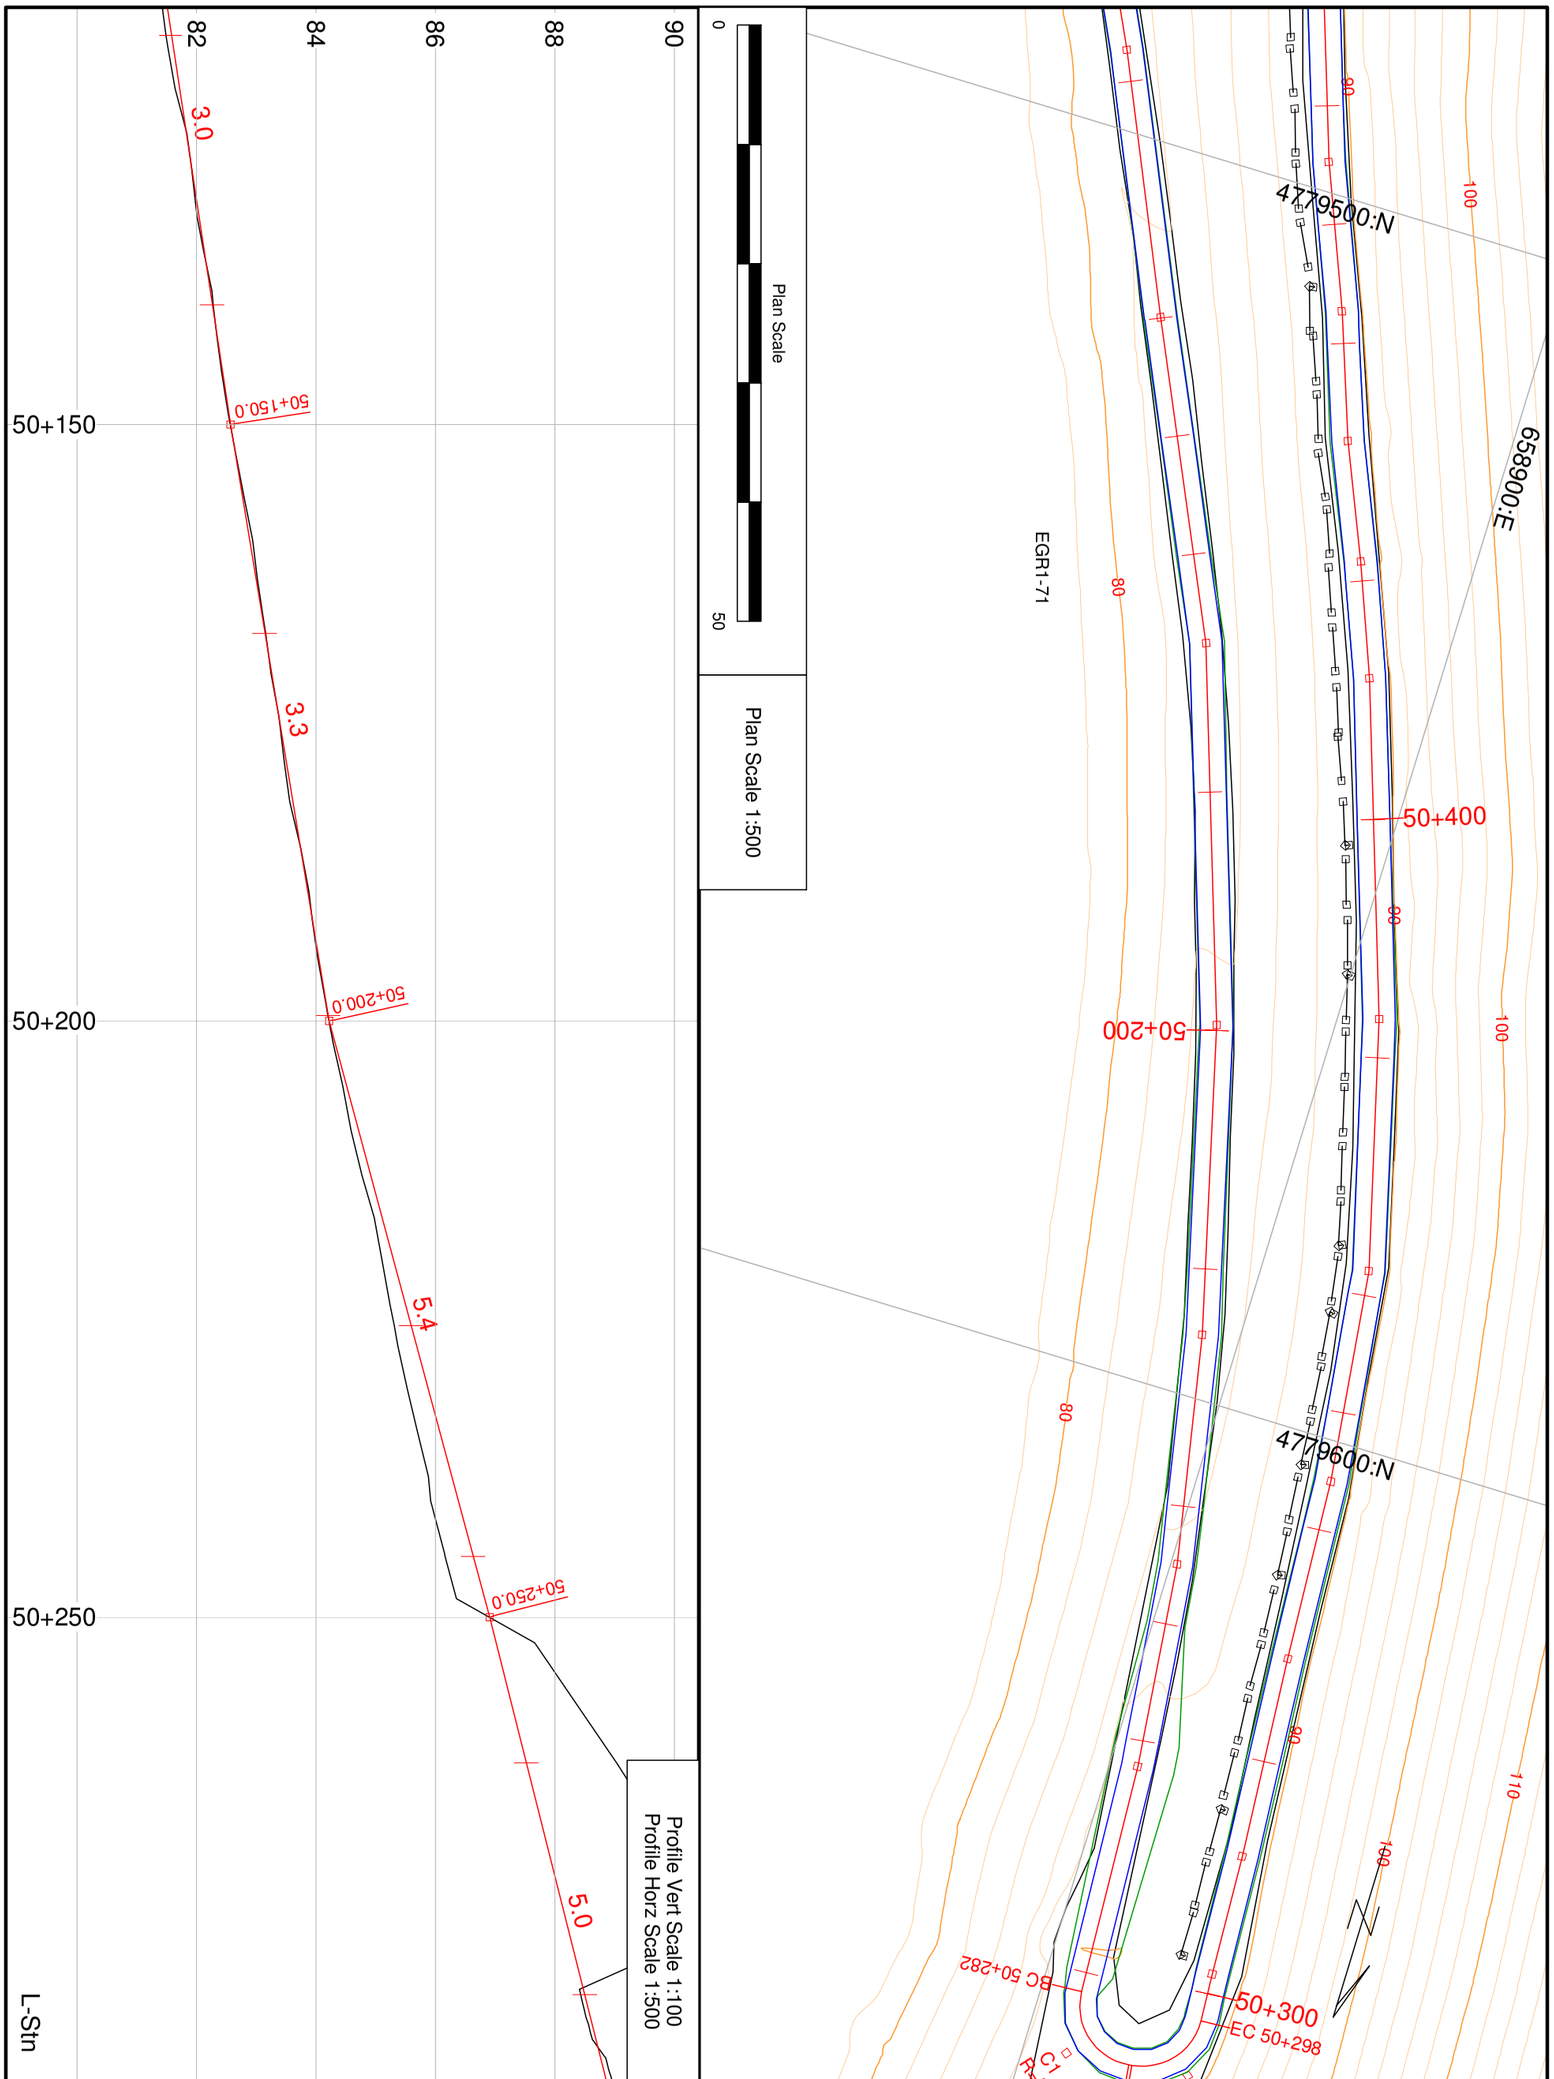
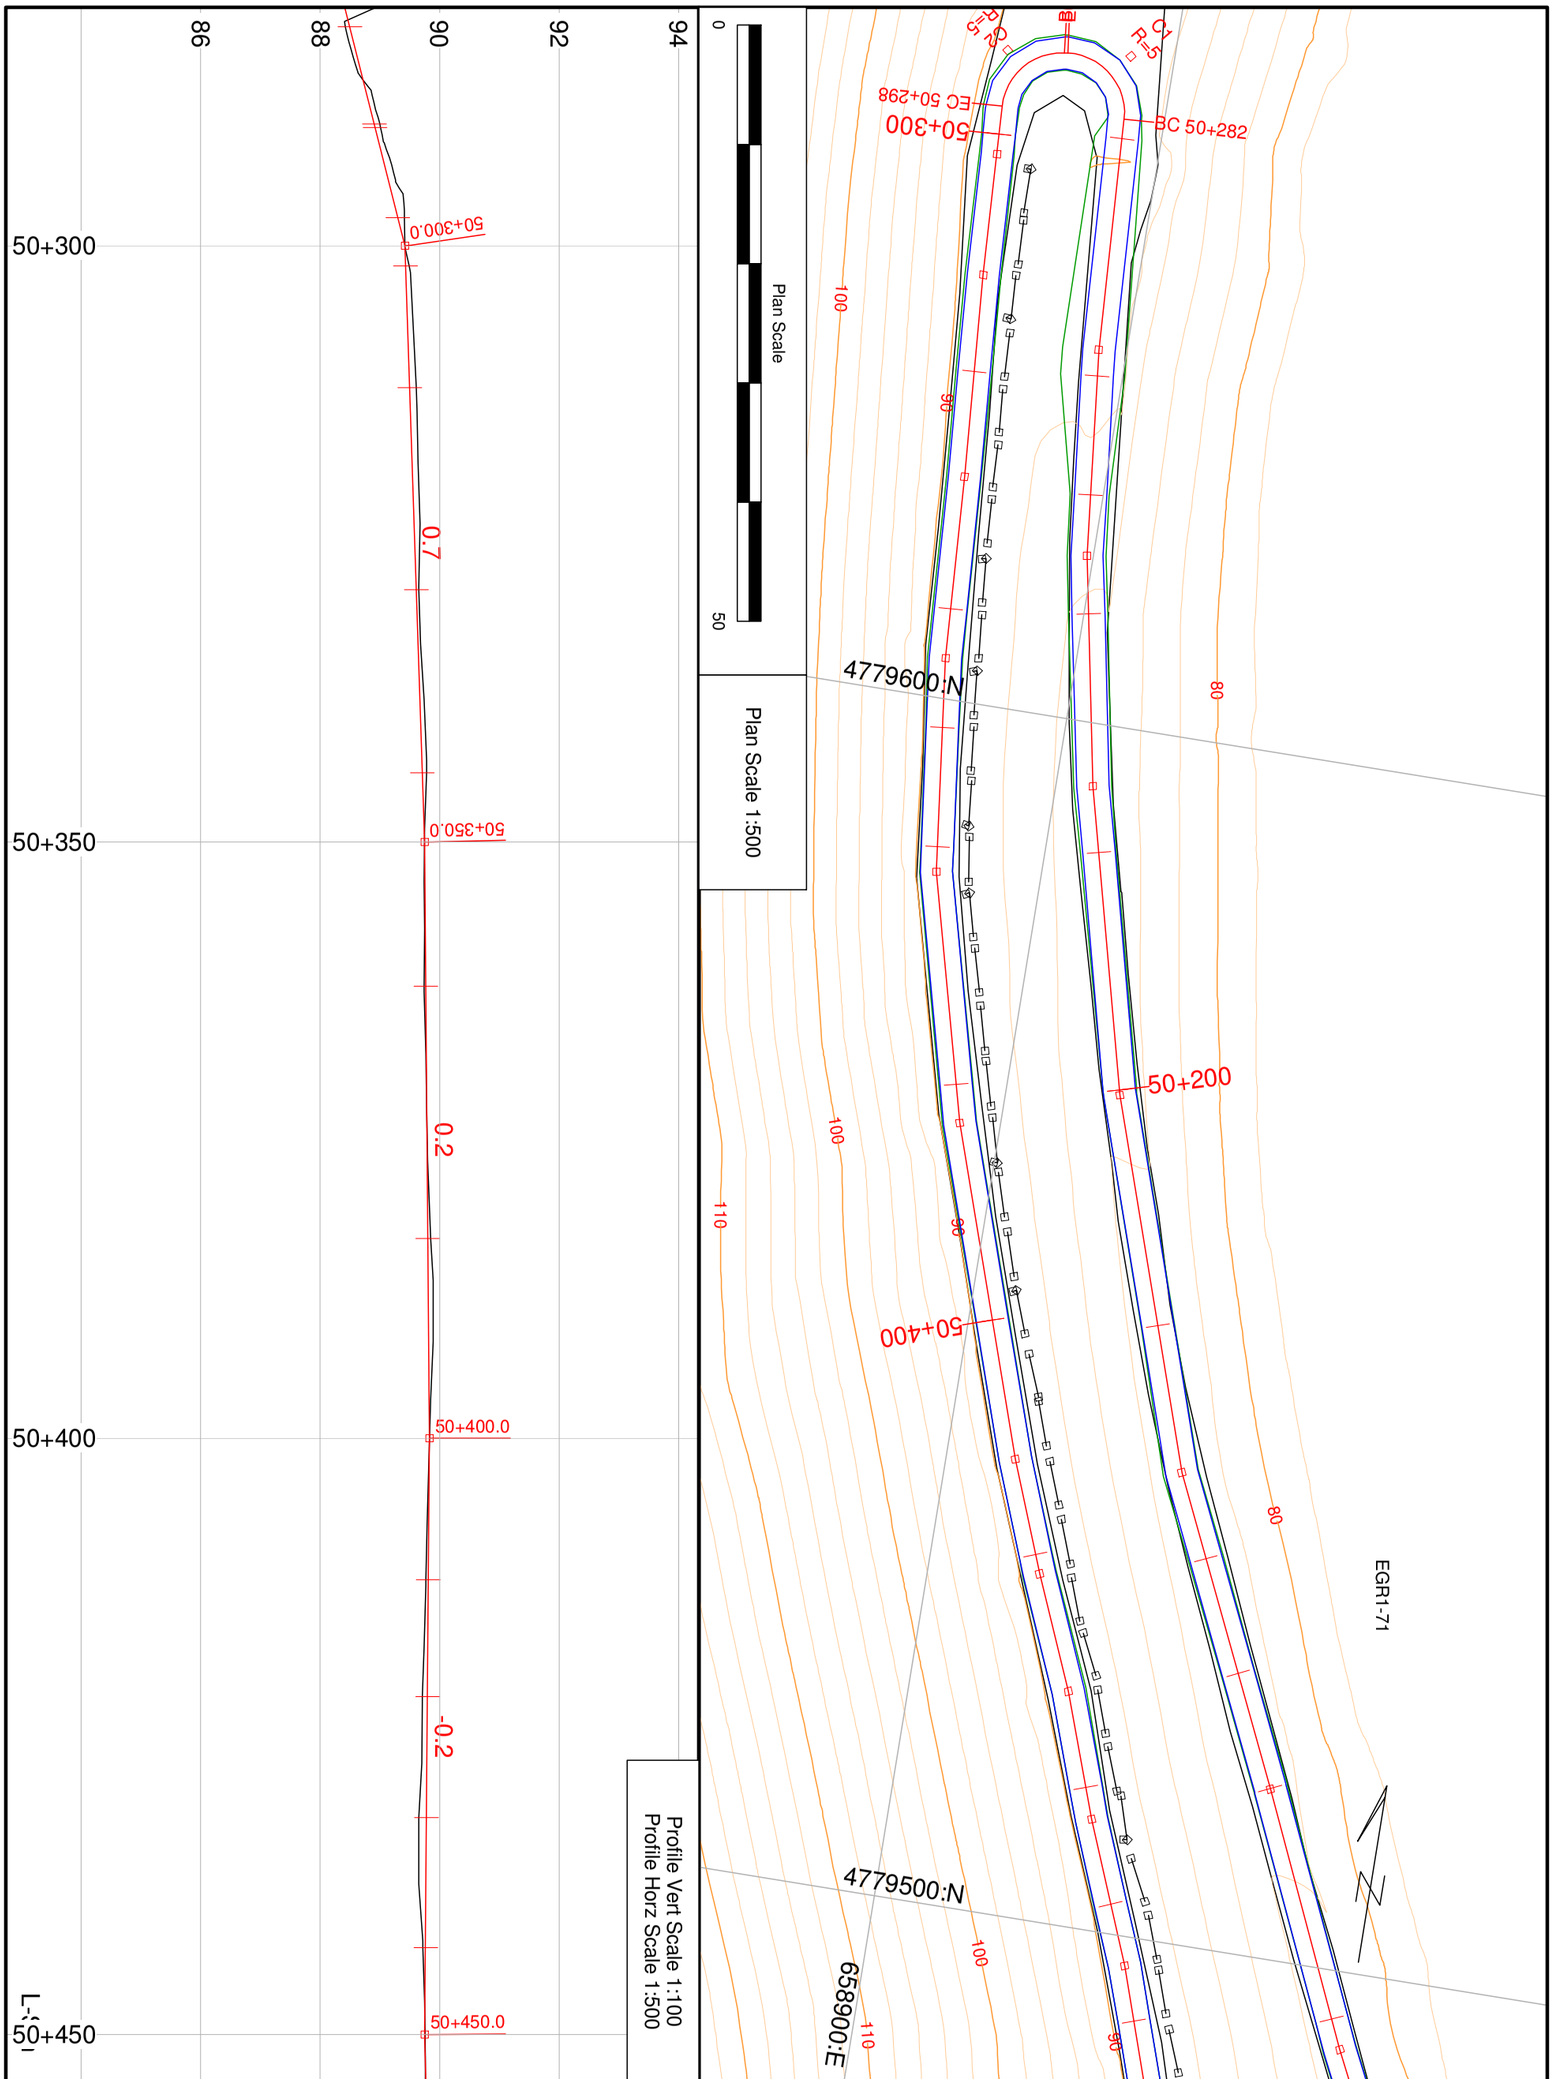
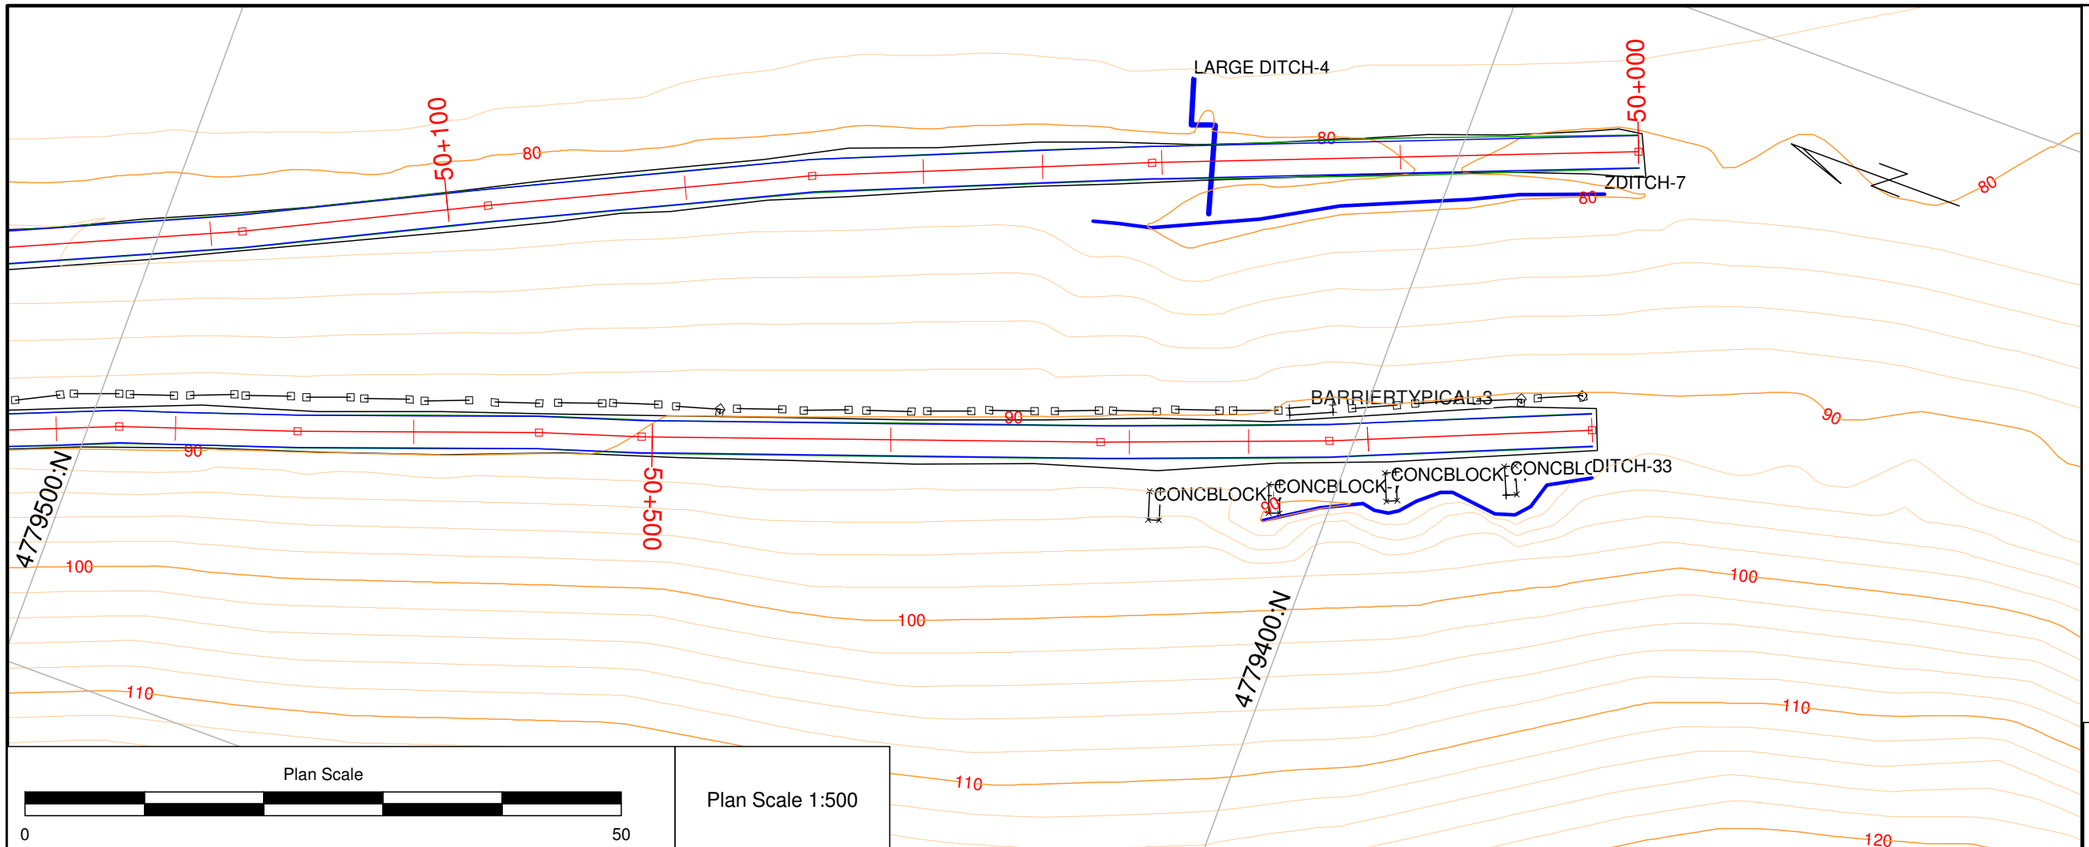
FIGURE 3b

A road of various widths (red centreline, blue edges in Figure 3) was superimposed on the road as surveyed with GPS (black edges in Figure 3). By trial and error it was found that a width of 2.4 m (8 ft) fit the narrowest stretches of the road. According to the DEM, there is minimal flat ground beyond the edges of the road, or the line of concrete barriers.

It is understood that the road is subjected to minimal pickup truck traffic, and that heavy trucks use it only very rarely. It is recommended that 100 mm of OPSS Granular A be placed and compacted on the road to improve it to an acceptable standard for the traffic it receives. Alternately, surplus road base material from the upgrading of the Glen Access Road could be used in place of the Granular A.

There is a need for a ditch to intercept the flow of water across the road from west to east. However, there does not appear to be sufficient space for a ditch. Consequently, it is recommended that a drain be installed along the western edge of the upper leg of the road. The drain could be constructed by digging a shallow trench along the

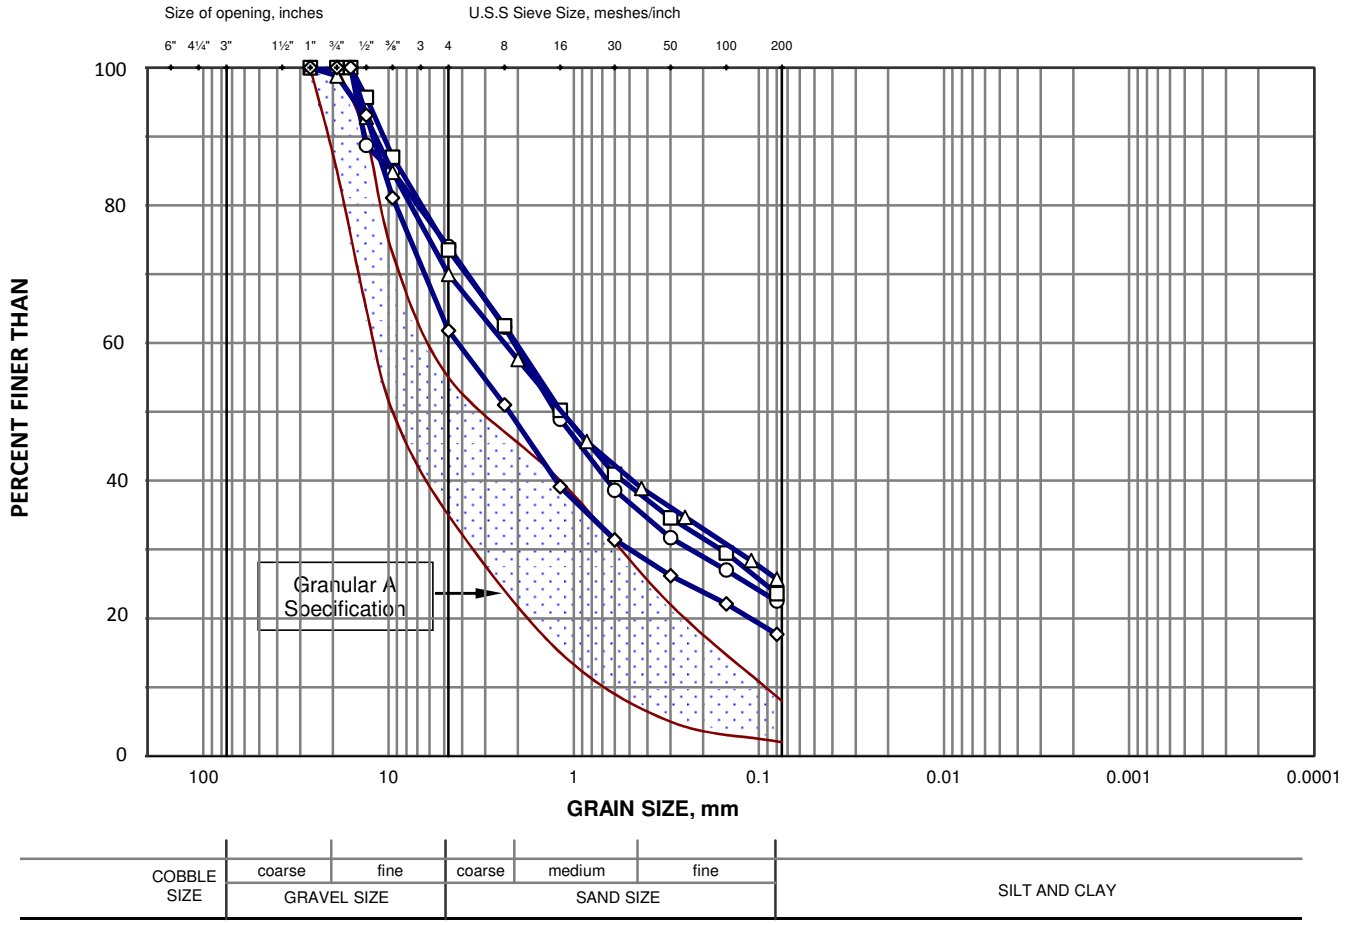
FIGURE C1

As shown by the grain size distributions (Figure C1), the existing road base material does not meet the specification limits for OPSS Granular A. As such it will have poor drainage characteristics. The recommended design therefore includes the removal of 150 mm of existing base material to be replaced with 150 mm of new

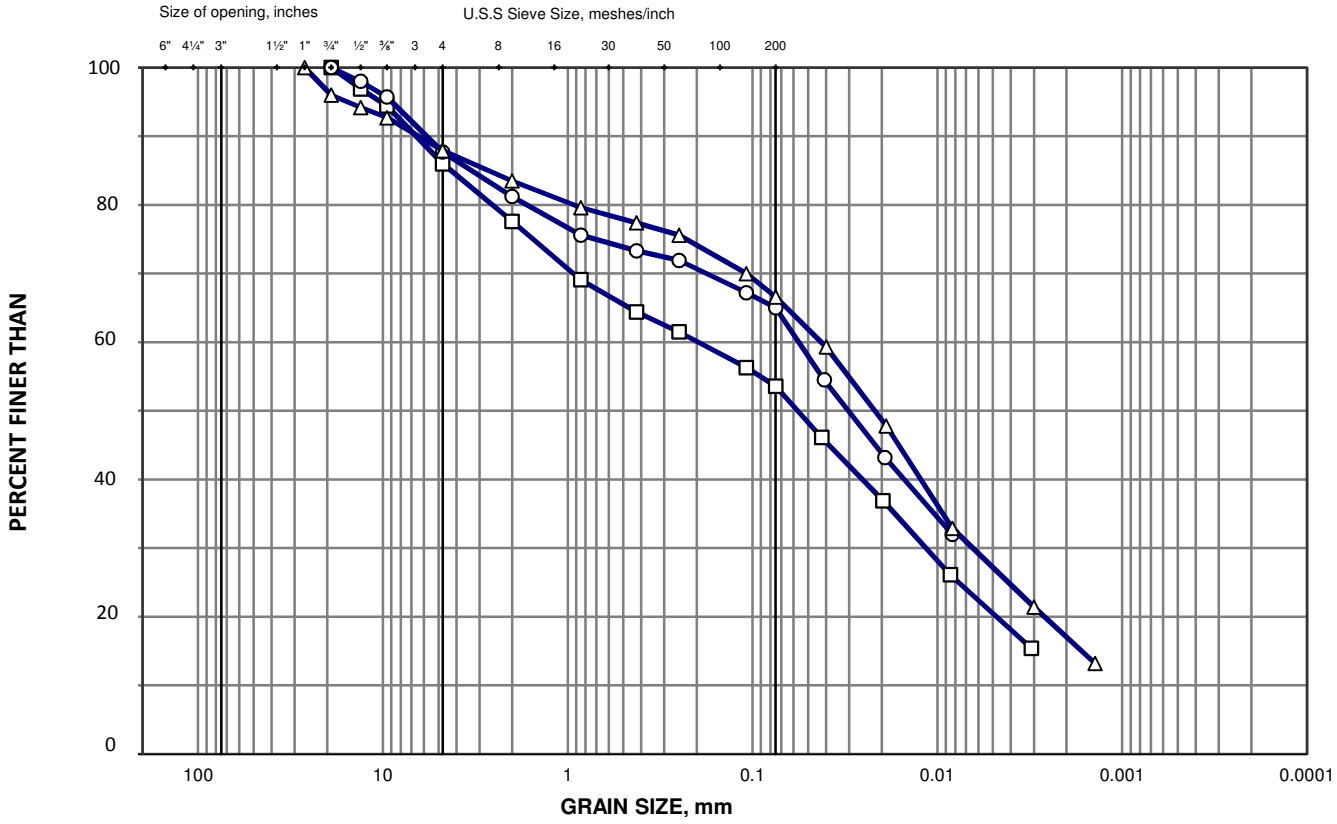
FIGURE C2

Grain size distributions for the silty clay found in BHs 1, 3, 5, 6, 7, and 8 are shown on Figure C2. The natural water content of samples of the soil ranged from 4.5 to 8.2 percent. As shown in Figure C3, two Atterberg tests indicated liquid limits of 29.4 and 22.8, and plasticity indices of 11.9 and 7.2.
